Air Quality Management Services, Inc.

Re: Limited Mold sampling at the Adult Education (Adult Ed) building at 20 Maplewood Avenue in Biddeford, Maine.

AQM Project #: 11-433

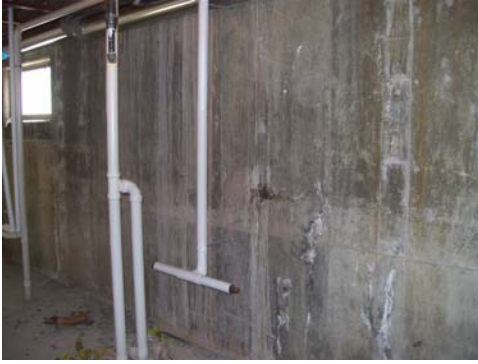
View of exposed concrete wall system in Laboratory Area (Adult Ed)

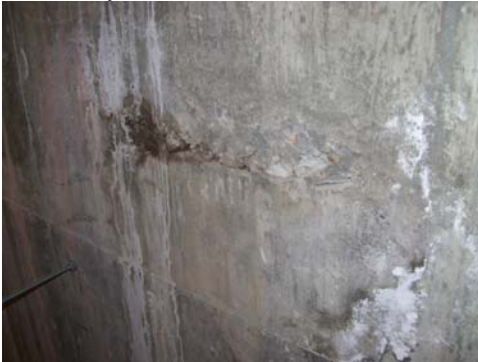
Efflorescence was observed on concrete wall surfaces, indicating that moisture has been moving inward through the foundation walls. This moisture must be controlled to prevent future impact and mold growth on finished materials. Consult a qualified engineer or contractor for methods to reduce groundwater influence on the foundation and/or prevent inward migration of moisture.

Laboratory Area (Adult Ed) – mold growth not observed on concrete wall; whitish areas are due to moisture infiltration (efflorescence)

Mold growth **was not** identified on the surfaces sampled – no current risks anticipated. Since mold-contaminated sheetrock was reportedly installed close to the concrete walls and subsequently removed, these concrete surfaces should be detail-cleaned (via HEPA-filtered vacuuming) prior to re-installation of finished wall systems. Ensure to clean visible dusts and construction debris in the affected areas as well, using a vacuum equipped with a HEPA filter.

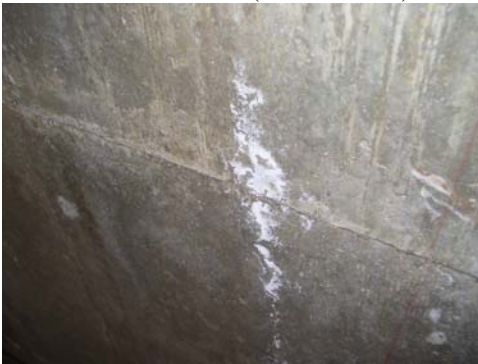
Laboratory Area (Adult Ed) – mold growth not observed on concrete wall; whitish areas are due to moisture infiltration (efflorescence)

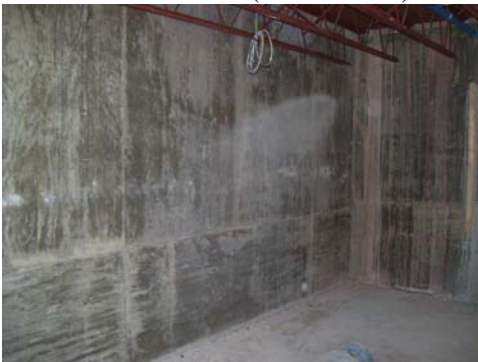
View of exposed concrete wall systems in Office Area, COTC Side (Adult Ed)

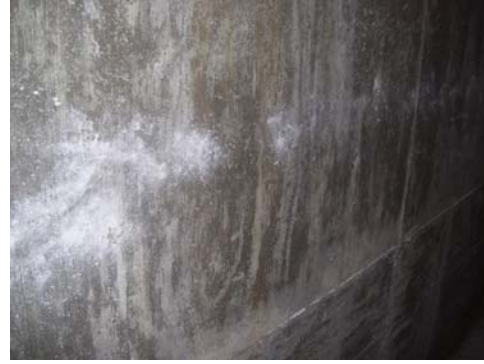
Office Area, COTC Side (Adult Ed) – mold growth not observed on concrete wall; whitish areas are due to moisture infiltration (efflorescence)

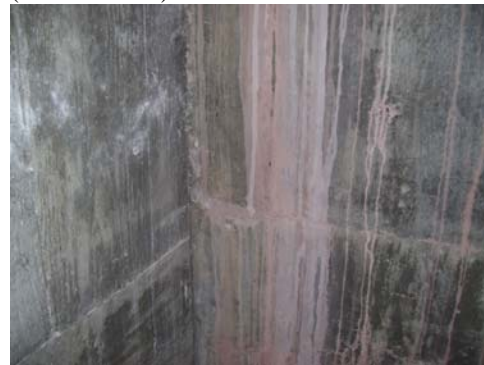
Office Area, COTC Side (Adult Ed) – mold growth not observed on concrete wall; whitish areas are due to moisture infiltration (efflorescence)
